## Occupational Safety and Health Administration

Inspection Number	1. Photo ID No.	2. Date/Time	3. Citation Number	4. Item Number	5. Instance No.
<b>1148200</b>	<b>8830, 8831</b>	<b>5/18/2016</b>	<b>1</b>	<b>1</b>	<b>1</b>

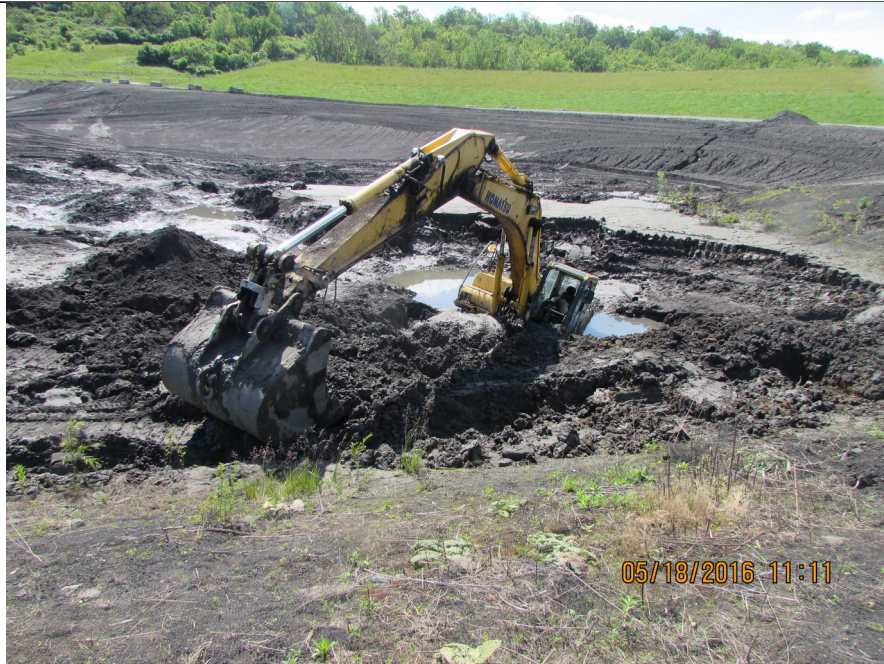
Komatsu PC350-8 Hydraulic Excavator that was being towed by the dozer

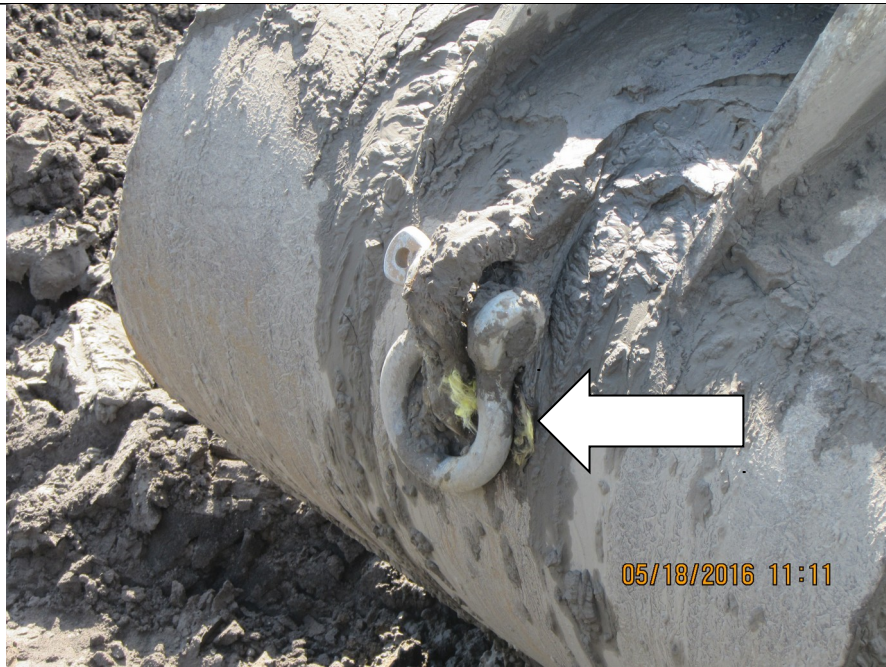
Location of the Copperhead Shackle WLL25T CA1-1/34A attached to the bucket of the excavator.  
Note: The 4" X 20' synthetic sling that broke free from the shackle during towing operation.
